# HOME INSPECTION REPORT

**313 Ridgewood Dr., Daphne, AL 36526**

**Inspection Date:**  
07/10/2017

**Report Number:**  
03-1708

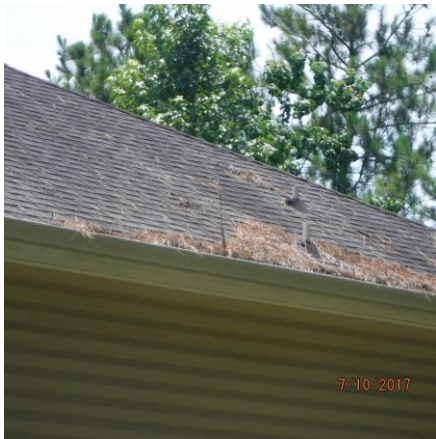
- **Improve:** Debris should be removed from the roofing.

Debris on Roof – Typical

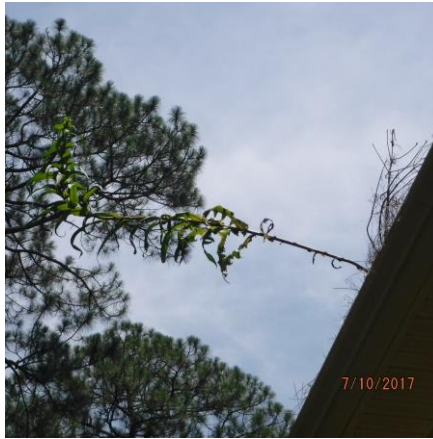
- **Improve:** The gutters require cleaning.

Gutters Clogged

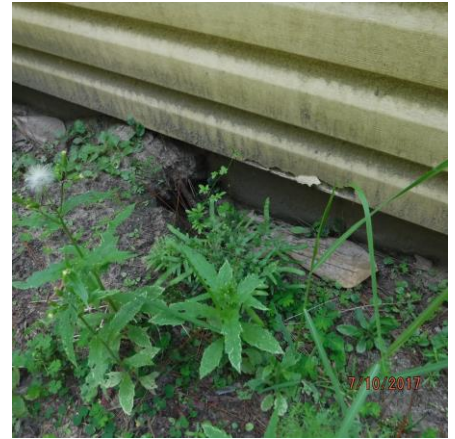
Erosion from Roof Discharge

- **Improve:** The lot is lower than adjacent lots. Grading improvements should be undertaken where possible. The general topography of the area is such that it will be difficult to control storm water entirely. During heavy rains, the accumulation of storm water on the lot may be unavoidable.
- **Improve:** Erosion from roof discharge was observed along the north wall.

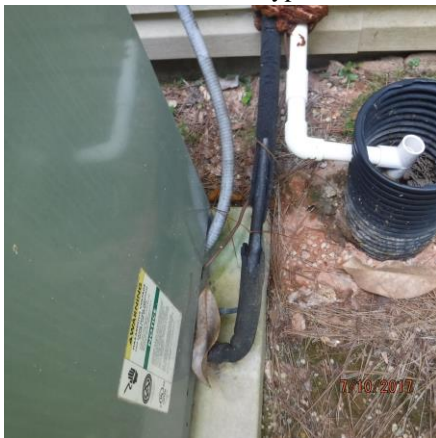
A/C Piping Insulation Damaged

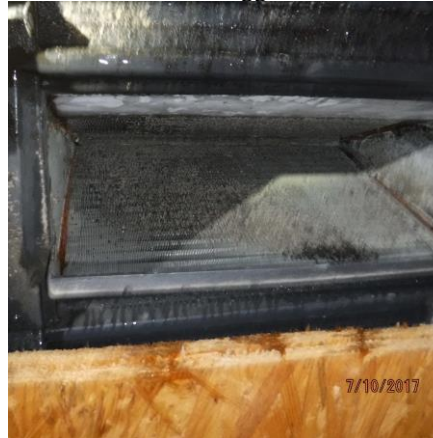
Evap. Coil Lacking Maintenance

- **Improve:** The evaporative coil has been lacking maintenance. A qualified heating and cooling technician should be consulted to further evaluate this condition and the remedies available for correction.

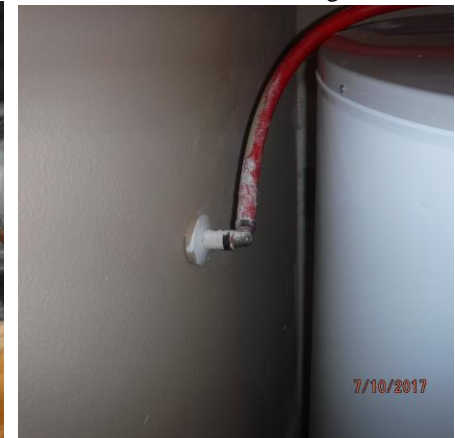
TPR Piping Reduces/ Not Rated

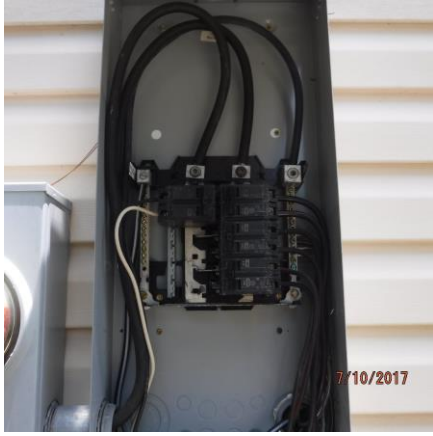
Main Panel in Good Order

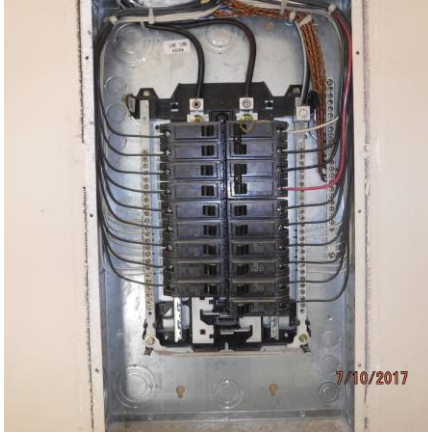
Auxiliary Panel in Good Order

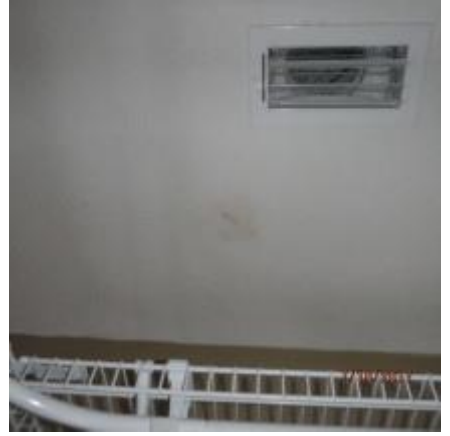
Ceiling Stains in Master Bed Room

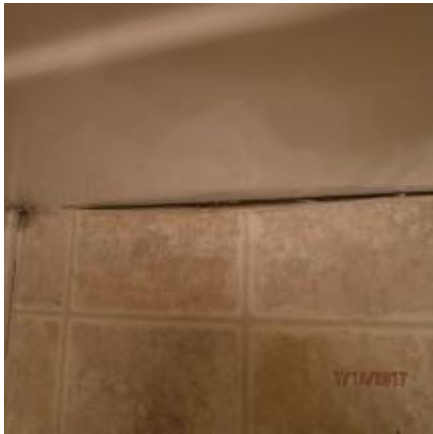
Seal Base of Tubs Where Meet Floors

- **Monitor:** The faucets are showing signs of age. Updating faucets over time should be anticipated.
- **Improve:** The shower head in both bathrooms are missing and should ideally be replaced.
- **Improve:** Cracked, deteriorated and/or missing bathtub enclosure grout and caulk should be replaced in both bathrooms where the tub meets the floor.

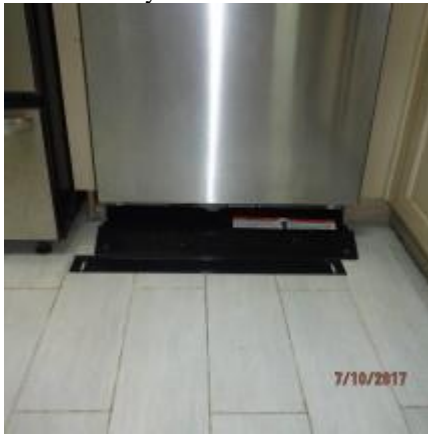
Base Plate Loose on Dishwasher

- **Improve:** The bottom plate is loose on dishwasher.
- **Improve:** The instant hot water dispenser is inoperative.

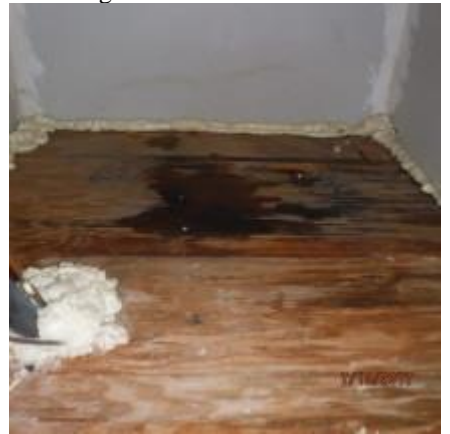
A/C Condensing into Plenum

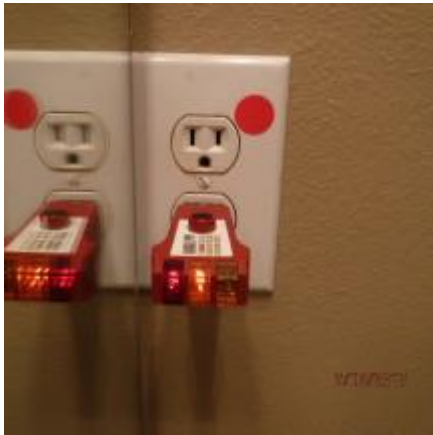
Bathroom Outlet Reversed Polarity

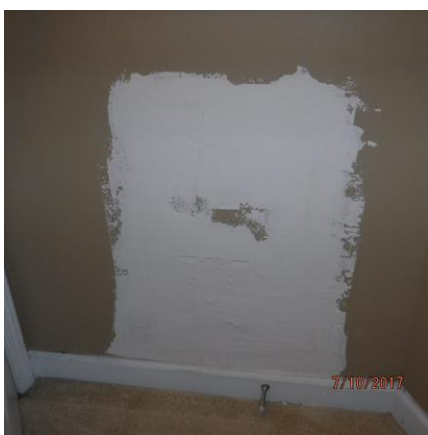
Patching in Master Closet

- **Monitor:** Water staining was noted in the master closet and laundry room.
- **Monitor:** Evidence of patching was detected in the master closet.
- **Monitor:** Damage to the interior finish was observed in the garage.
- **Monitor:** Minor cracks were noted.

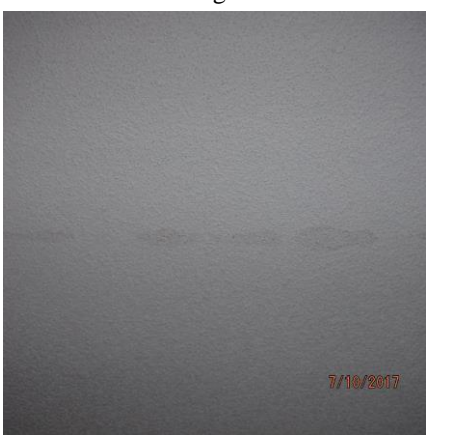
Water Stains in Laundry Room

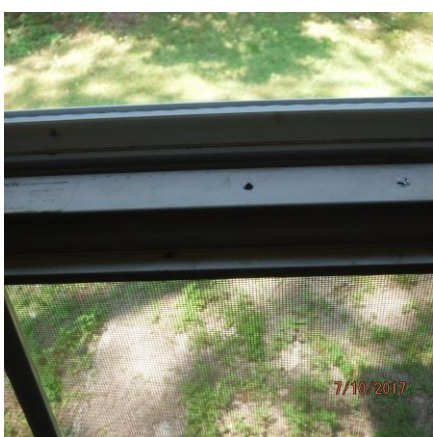
Window Hardware is Missing

- **Improve:** Window hardware is missing in the half bathroom.

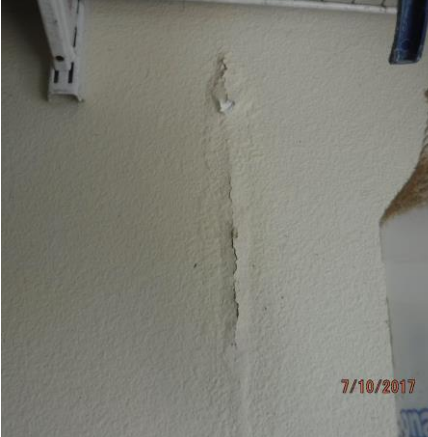
Damage in Garage
